DEPARTMENT OF TRANSPORTATION**DIVISION OF ENGINEERING SERVICES**

Contract #: 04-0120F4Cty: SF/ALA Rte: 80 PM: 13.2/13.9File #: 69.28**WELDING INSPECTION REPORT****Resident Engineer:**Siegenthaler, Peter**Address:** 333 Burma Road**City:** Oakland, CA 94607**Report No:** WIR-019199**Date Inspected:** 06-Jan-2011**Project Name:** SAS Superstructure**OSM Arrival Time:** 700**Prime Contractor:** American Bridge/Fluor Enterprises, a JV**OSM Departure Time:** 1900**Contractor:** Zhenhua Port Machinery Company, Ltd (ZPMC), Changxing Island **Location:** Shanghai, China**CWI Name:** Shi Lei**CWI Present:** Yes No**Inspected CWI report:** Yes No N/A**Rod Oven in Use:** Yes No N/A**Electrode to specification:** Yes No N/A**Weld Procedures Followed:** Yes No N/A**Qualified Welders:** Yes No N/A**Verified Joint Fit-up:** Yes No N/A**Approved Drawings:** Yes No N/A**Approved WPS:** Yes No N/A**Delayed / Cancelled:** Yes No N/A**Bridge No:** 34-0006**Component:** OBG Segments**Summary of Items Observed:**

Weld Lab

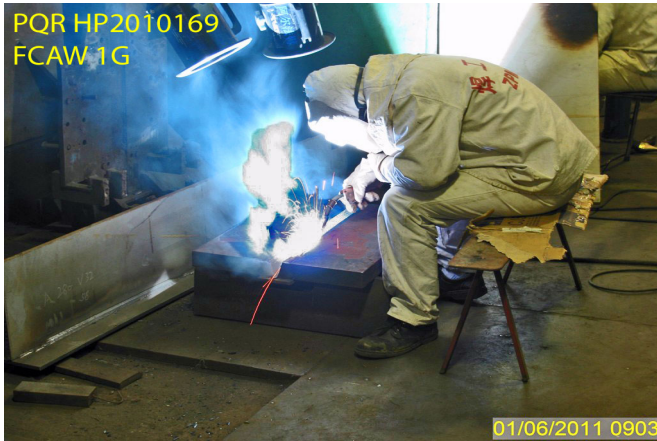
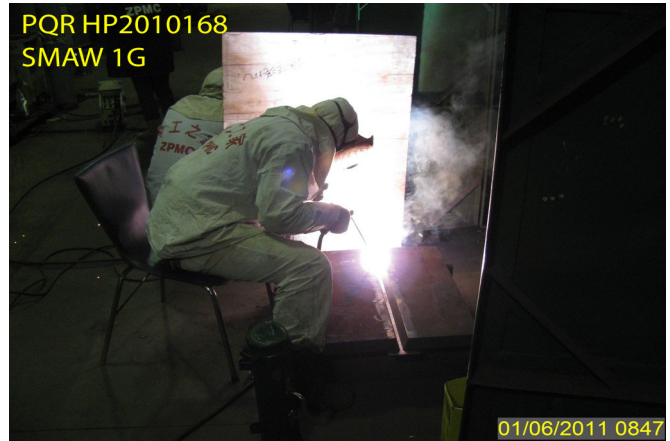
HP2010169 using the Flux Cored Arc Welding (FCAW) process in the 1G (flat) position using Supercored 71H E71T1-1 electrode. The electrode is 1.4mm in diameter. The Welding Procedure Specification (WPS) followed was PWPS-B-T-2231. The test plate configuration was a Complete Joint Penetration (CJP) Single V Groove Butt Joint, 50mm in thickness and 700mm in length using steel backing. The test plate material is identified as ASTM A148 (casting). The welder was identified as Li Liang.

HP2010163 using the Flux Cored Arc Welding (FCAW) process in the process in the 1G (flat) position using TL-508 E7018 electrode. The electrode is 5mm in diameter. The Welding Procedure Specification (WPS) followed was PWPS-B-T-2211. The test plate configuration was a Complete Joint Penetration (CJP) Single V Groove Butt Joint, 50mm in thickness and 700mm in length using steel backing. The test plate material is identified as ASTM A148 (casting). The welder was identified as Li Qing Tian. Test Plate was not completed on this date

Unless otherwise noted, all work observed on this date appeared to generally comply with applicable contract documents.
